**A STUDY OF THE CONDITIONS  
OF A VARIETY OF THE  
EARTHQUAKE HIT VILLAGES  
IN GARHWAL**

**MADE **THREE** MONTHS AFTER THE DISASTER**

**T. R. CHANDRA DATH & LAURIE BAKER**

**OF COSTFORD**

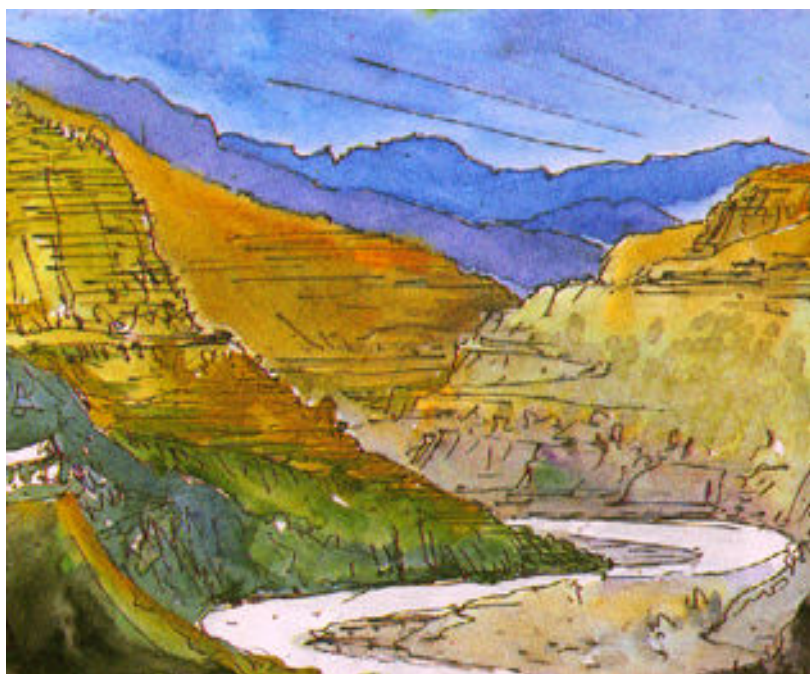
## **EARTHQUAKE COUNTRY RIVERS VALLEYS MOUNTAINS**

This is Garhwal Earthquake country. Strong, swift rivers at the bottom of deep valleys. Slopes of the mountain side on both sides is steep, rocky and barren. Some of it is covered with narrow terraces for cultivation – other parts are covered with Chir pine.

Sometimes fairly large villages are situated on flatter ground bordering the big rivers, though they are usually twenty or more metres above water level to avoid damage at flood times.

The main river valleys have well maintained roads. Bridle paths are quite independent and were originally built for the use of foot and animal transport. They usually link the valley with others, are paved with stone and are often stepped up the steep slopes.

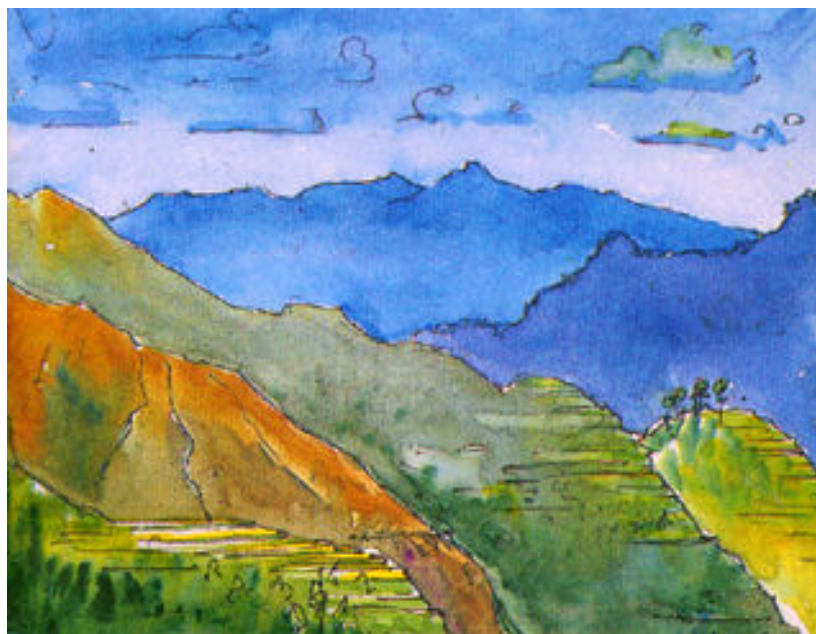
### **SOME ROADS GO OVER PASSES MORE THAN 6000 FEET HIGH**

This sketch is much higher up the valley. On important routes the good road will wind up and up, often to a height of more than six or seven thousand feet, where it gives through a pass and over into the next valley.

The Bridle paths have taken a much shorter steeper route but cross over the pass at the same place. The old Dak Bungalows were also found in these passes.

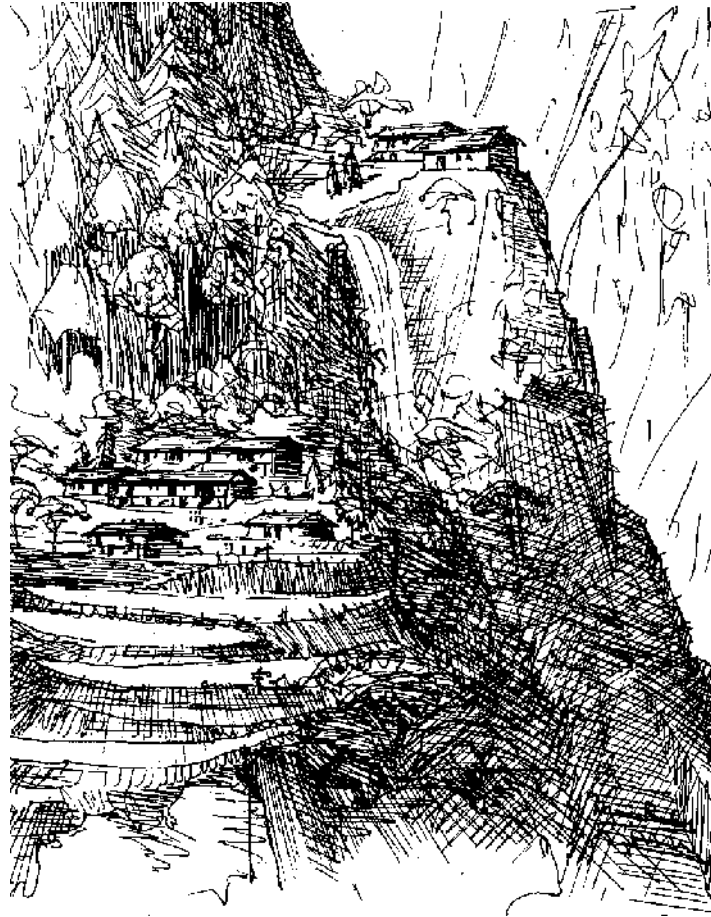
### **HOUSES ARE ONLY BUILT WHERE THERE IS PERMANENT WATER**

People build their homes where there is a more-or-less permanent supply of water – mainly from springs coming out of the mountain sides.

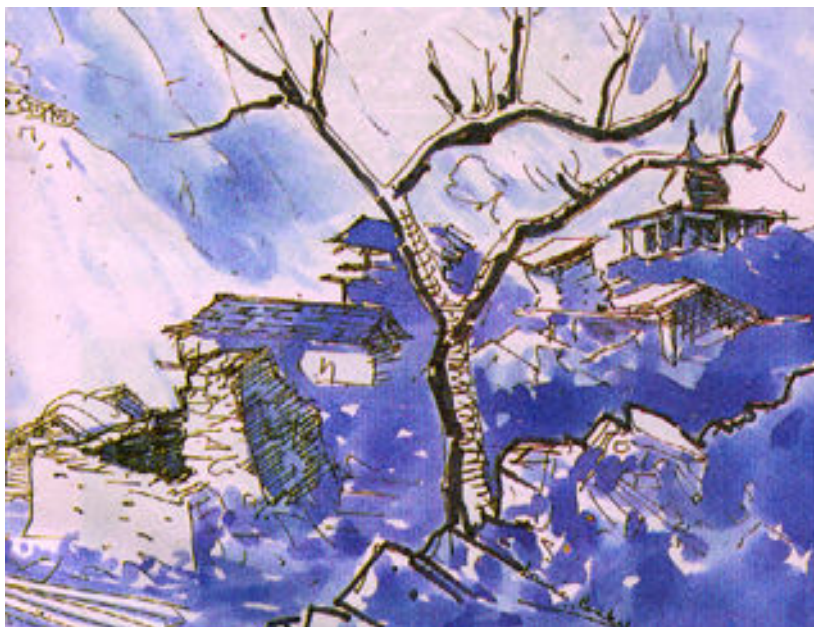
**THREE MONTHS HAVE PASSED SINCE THE EARTHQUAKE  
MUCH OF THE RELIEF WORK HAS BEEN DONE  
NOW COMES THE TASK OF REPAIRING AND REBUILDING**

It is important to keep in mind that this report is being done almost three months after the earthquake took place – so most of the urgent relief work has been done and now there is the main task of getting back to normal – in particular – the repair of damaged buildings and the rebuilding of destroyed ones.

What was most distressing and disturbing was that three months after the earthquake 95% of all the damaged and destroyed buildings we saw remained exactly as they were on morning of October 20<sup>th</sup> 1991.

Various explanations / excuses were offered and recommendations are made later in this report to deal with this situation.

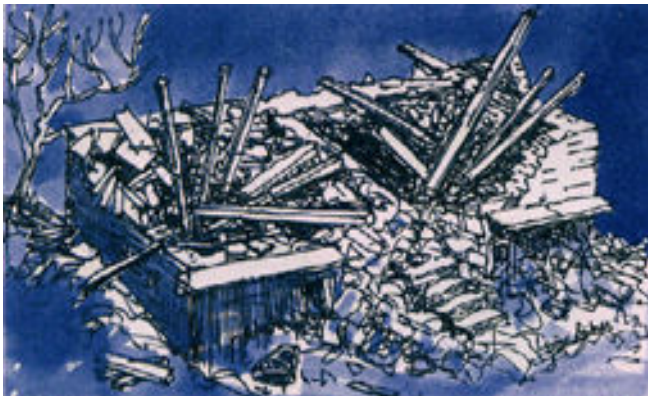
**A TYPICAL “TOTALLY DESTROYED” HOUSE**

Three months after the earthquake this sketch was drawn of what was called a totally destroyed house in a village about 5000 ft. up. Some houses were also partially damaged and some untouched.

**AFTER 3 MONTHS NO CLEARING UP, NO SALVAGING**

No effort has been made to clear away the mess and salvage good material like wooden ballis (beams), door and window frames, slates and stones etc. The upper walls of the house had fallen and of course the roof followed.

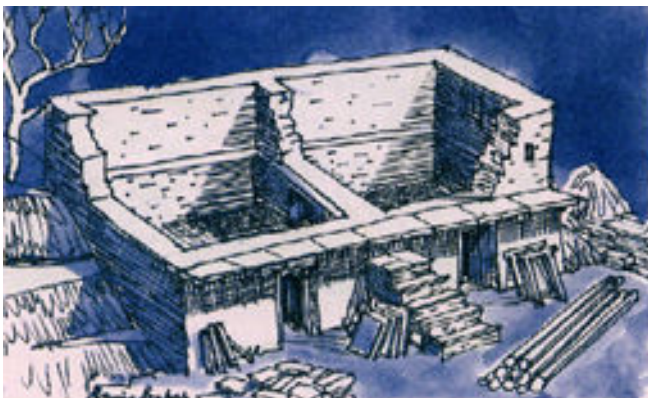
**ALL ROOFING & FLOORING MATERIAL  
COULD BE SALVAGED & USED**

In fact, the house is **NOT** totally destroyed. The lower sketch shows what it would look like if clearing – up a salvaging had been done. We crawled into the lower storey and found the walls undamaged.

**“IF WE CLEARUP, THERE’LL BE LESS COMPENSATION”**

The occupants and other villagers said that if they cleared away all the mess they would get less compensation. This non – action and explanation for it was heard throughout our entire study.

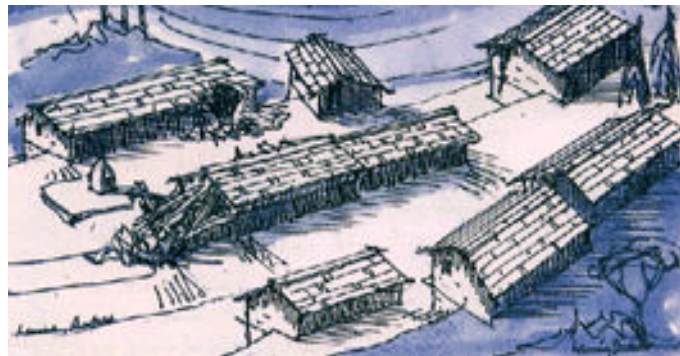
**THE SAME VILLAGE DEPICTED AS HAVING RECEIVED A TYPICAL MIXTURE OF DAMAGED & UNDAMAGED HOUSES. MANY SUCH VILLAGES WERE SEEN.**

The middle sketch is imaginary – it shows a certain amount of damage, the end of one row of houses collapsed: another with part of a wall, and the roof above it fallen in and several walls with cracks in them. There were many villages like this. Bad for the individual concerned but by no means a “Big disaster” for the village.

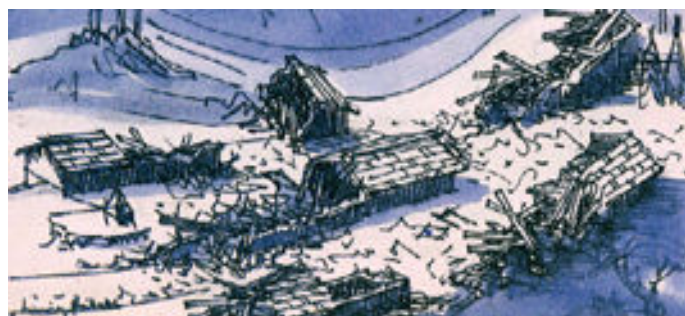
**THE SAME VILLAGE DEPICTED AS “TOTALLY DESTROYED” A RELATIVE FEW SUCH VILLAGES WERE SEEN AND VISITED.**

The bottom sketch is similarly imaginary - that is, the top village “totally destroyed”. We saw a few – but **NOT** a lot of such villages. As has been shown elsewhere – “totally destroyed”, is an exaggeration – though there is no denying that it has been a great disaster for such villages.

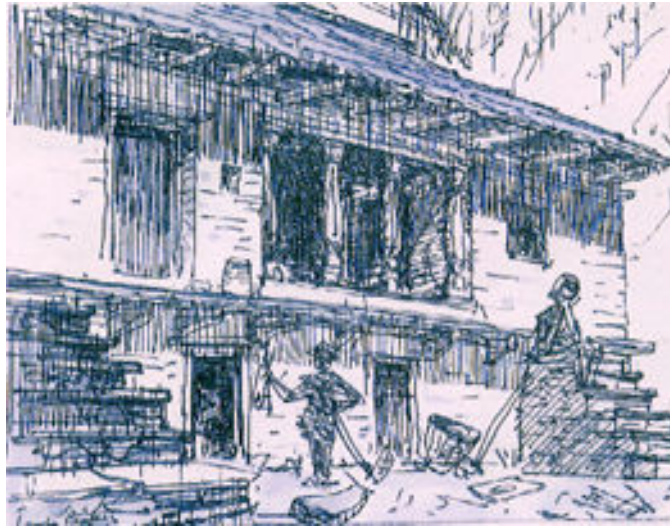
**A TYPICAL HOUSE  
ANIMALS LIVE BELOW  
A FAMILY ABOVE**

The top picture shows a typical mountain-side house built on a narrow shelf of land about 6000 ft. above sea level. The lower storey houses the cattle and is cut back into the ground. There is a four foot high door only on the front side, and on other openings or windows. The back wall is cut out of “Mother Earth”. The walls are of local stones set in mud mortar. The roof is of large slates bedded in mud above split pine carried by whole pine tree trunks. A family lives in two or three rooms on the first floor.

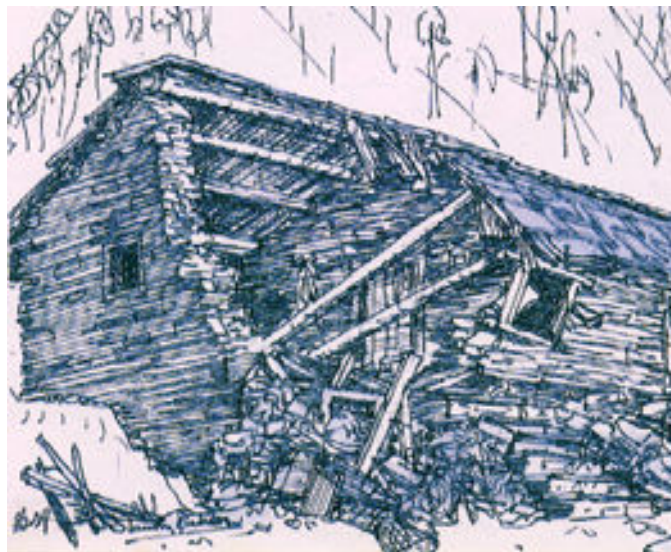
**THE OTHER END OF THE SAME HOUSE AFTER THE EARTHQUAKE  
ONE HALF DESTROYED THE OTHER HALF UNTOUCHED**

The bottom picture shows the other end of the same building after the earthquake. Both ends were built at the same time (about sixty years ago) by the same mason and carpenter using the same stones, mud, timber etc. The earthquake has destroyed one half and left the other half untouched.

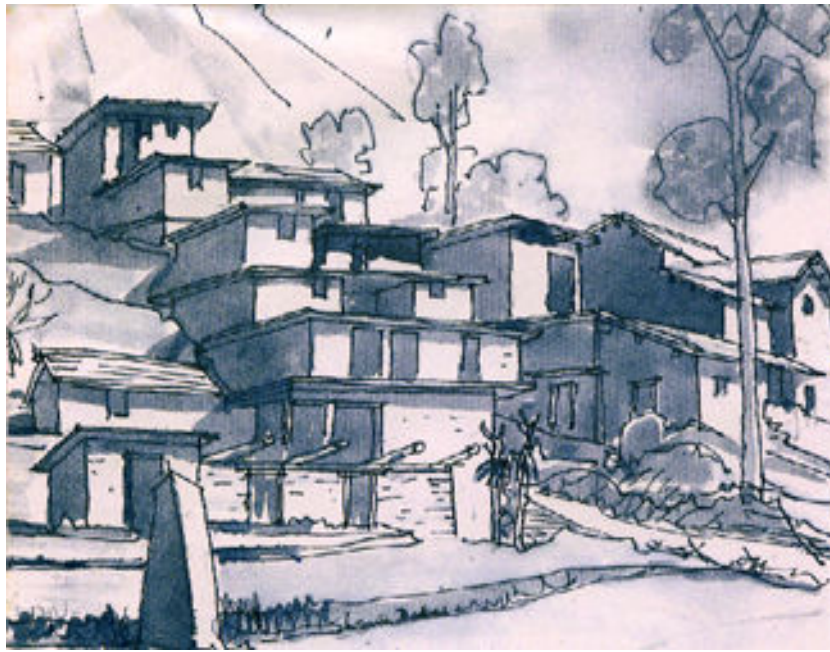
### **CONCRETE ROOFS HAVE COME TO SOME ROAD SIDE VILLAGES**

Some road-side villages have been able to use reinforced concrete (steel, sand and cement have been brought by lorry from the plains.)

### **BUT THEY ARE AS VULNERABLE AS THE TRADITIONAL WOOD AND SLATE ROOF**

The lower picture shows clearly that a “concrete house” is just as liable to destruction or damage from the earthquake as is the old-fashioned wood, mud and slate roofed house.

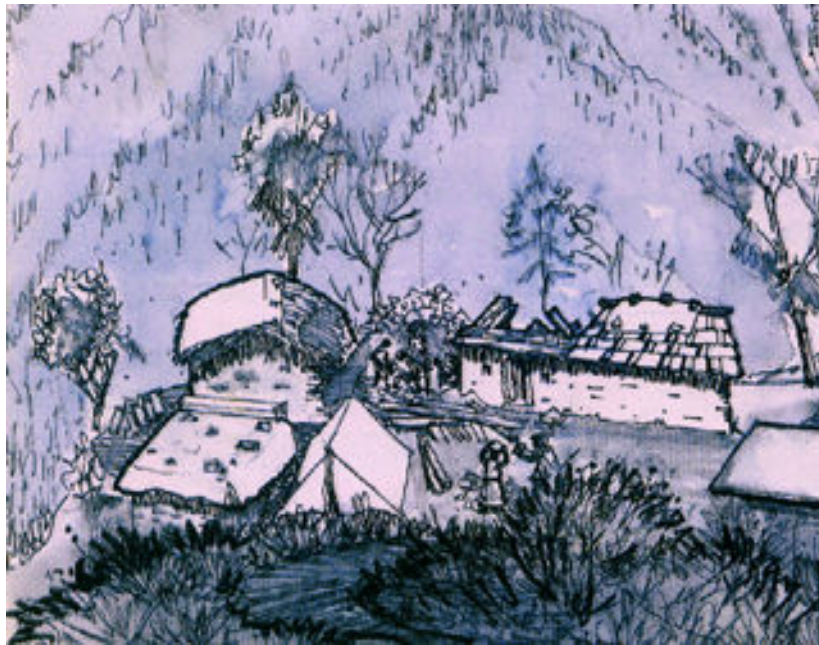
**VIEW OF A TYPICALLY DAMAGED VILLAGE  
ONE OR TWO HOUSES UNDAMAGED**

This sketch is of a typical small hamlet of only four houses. The one on the right had a concrete flat roof and remained undamaged.

The long one, middle right, was untouched on one half and the front wall and roof had fallen in the other half. A “relief” plastic sheet had been placed over a slightly leaking roof.

**OTHERS PARTIALLY DAMAGED**

The thatched house on the right was untouched but a plastic had been draped over the thatch “in case it leaked.”

**BEING NEAR TO A ROAD RELIEF MATERIALS HAD ARRIVED  
AND WAS BEING MADE USE OF**

The building in the left fore front was under construction and what there was of it was undamaged. A “relief plastic sheet” was put over the top and it is being used by the occupants of the damaged roof house. They are not clearing up, except to retrieve household effects, for fear of not getting compensation.

The relief team “came to the village” so they put it up.

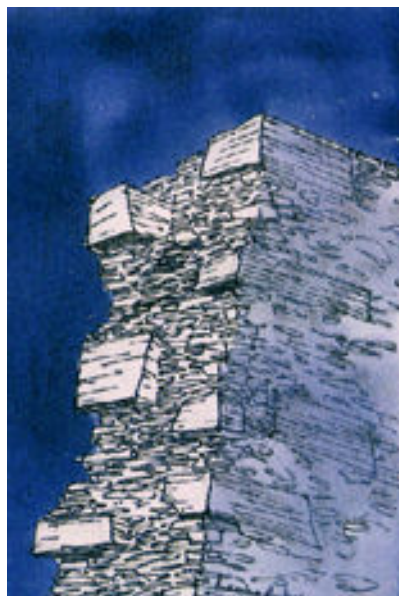
**WALLS MAINLY MADE OF A FEW LARGE STONES  
AND LOTS OF SMALL STONES BEDDED IN MUD**

This sketch shows what a broken wall looks like. It also clearly shows how big stones or a lot of little bits of stone are set together in mud. Clearly, there is no attempt at “bonding” (interlocking stones on one side of the wall with stones on the other side.)

**FATAL**

**WHEN THE WALLS FALL THE ROOF FOLLOWS**

On the outside the wall looks very neat and nice but as can be seen every where, this lack of bonding has proved to be fatal, especially because if the wall collapses the roof also automatically falls down.

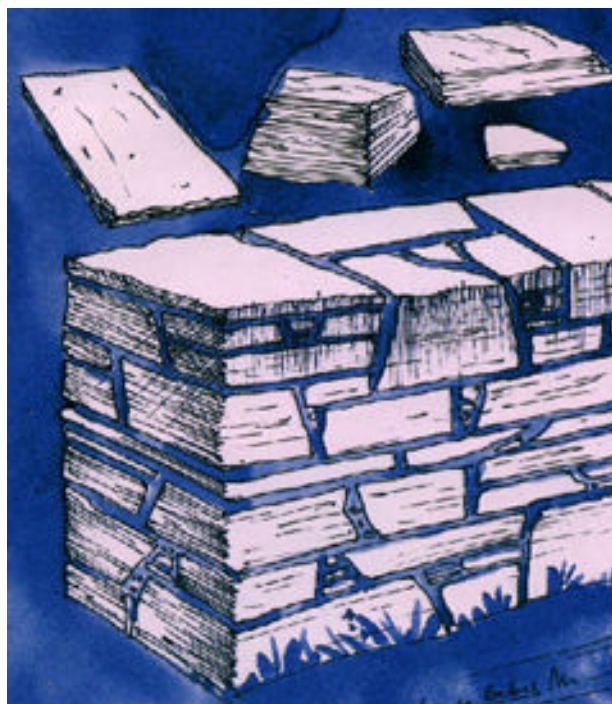
## STONES ARE GENERALLY OF A GOOD SHAPE

The stones in most areas (except along the lower river banks) are of an ideal shape for building. They are rectangular and cube like and could even strongly be built as dry-stone walls – that is, without mortar. People don't like this because of a fear that the cracks and spaces will provide housing for snakes, rats and other vermin.

## SALVAGE THEM AND USE THEM FOR RE-BUILDING

The picture shows how the salvaged reasonably sized stones should and can be used for rebuilding.

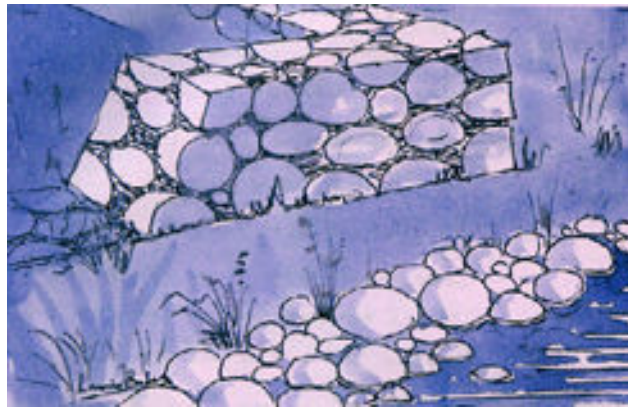
### **RIVERSIDE STONES ARE SMOOTH AND ROUND AND DO NOT MAKE STRONG WALLS**

Along the sides of the rivers the stones are rounded, smooth and as big as footballs. They are broken into two halves and used for building walls.

As the sketch shows the flat inside is used as the facing stone of a wall and the spaces in between the stones are filled up with small stones and pieces of stones. Due to the smooth rounded shape of each stone it is easy for them to slip and slide out.

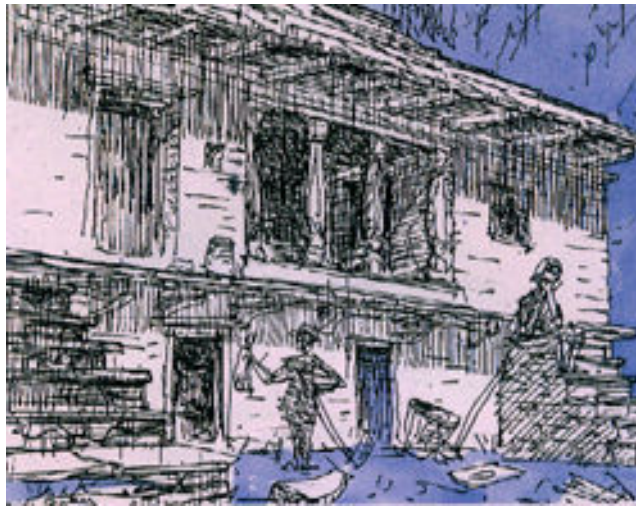
### A NEW HOUSE PLAN IS MAINLY NOT REQUIRED

Regarding the request for new house plans, we are strongly of the opinion that, on the whole, new or different plans are **NOT** required.

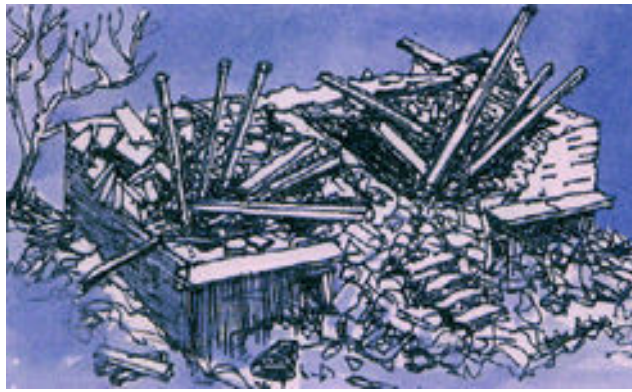
**AFTER CLEARING, THE ORIGINAL HOUSE PLAN IS VISIBLE  
AND MAINLY SOUND AND RE-USABLE**

As has been clearly shown, when debris is cleared away, even in the so-called “totally destroyed” houses – the foundations are still there, mainly intact, and the “plan” of the house is clearly shown, still existing.

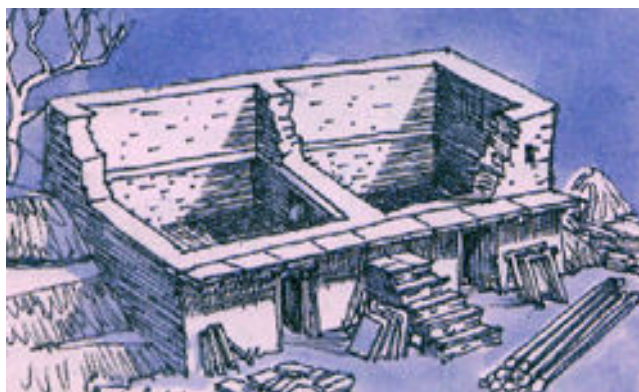
**MORE IMPORTANT THAN A NEW PLAN IS TO INCORPORATE IMPROVEMENTS  
INTO THE ACCEPTED TRADITIONAL PLAN**

So, far more important is to rebuild in a more stable way and incorporate improvements as and when required. For example, water storage can be incorporated in the lower basement, or energy efficient *chulhas* (stoves) can be built in to the rebuilt structures.
